The Early Church

How has this church changed over the years?

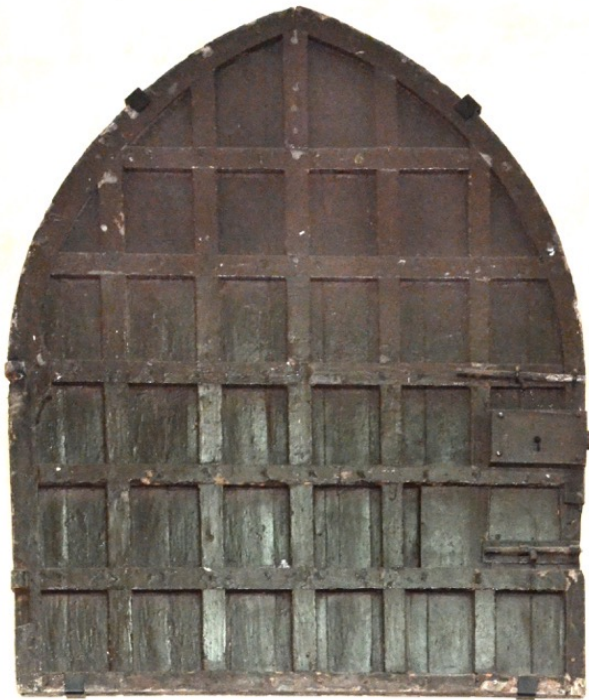
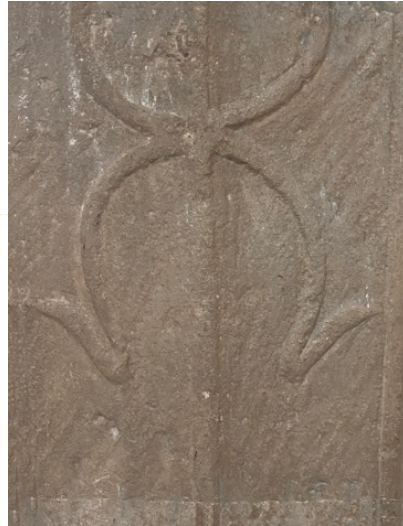
Above -
Detail from
coffin lid
Left -
C13th Door

There is no identifiable part of the Priory which stood roughly where Christchurch Mansion now stands. Of an early church on this site nothing remains save the door, now hanging on the north aisle wall, and a stone coffin lid beside the south door.

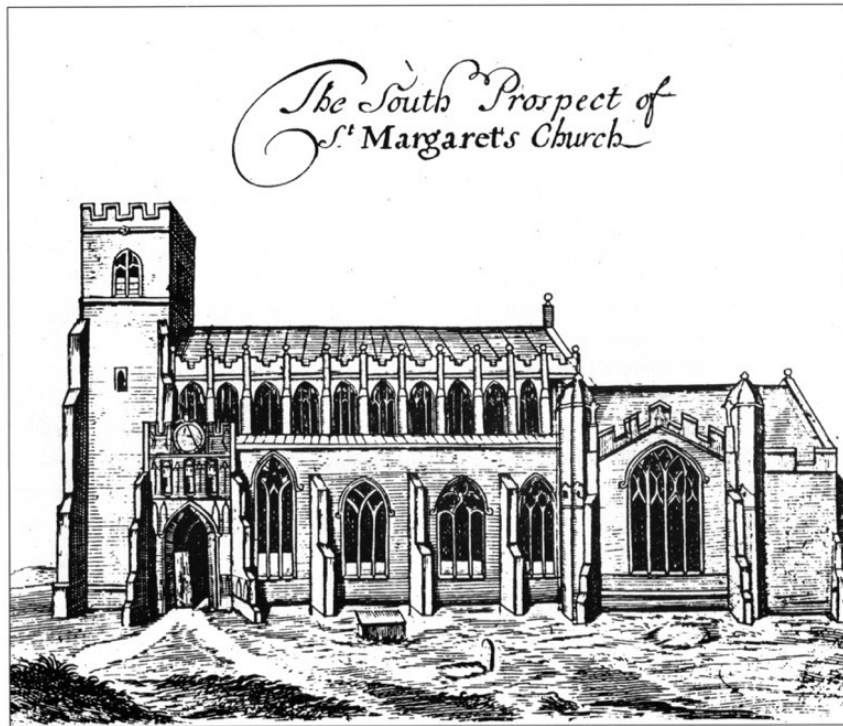
From John Ogilby's Map of Ipswich, drawn 1674, published 1698

Pen and ink drawing by Isaac Johnson, c. 1800

The earliest picture of the church on the left dates from 1674. There is a plain edge to the line of the south aisle wall where it joins the roof. In a later picture (c1800) on the right the sundial on the porch has been replaced by the clock face on the tower. There is also only one arched louvre on each side at the top of the tower. As you look at the pictures below see how the path to the south door has moved over the years.

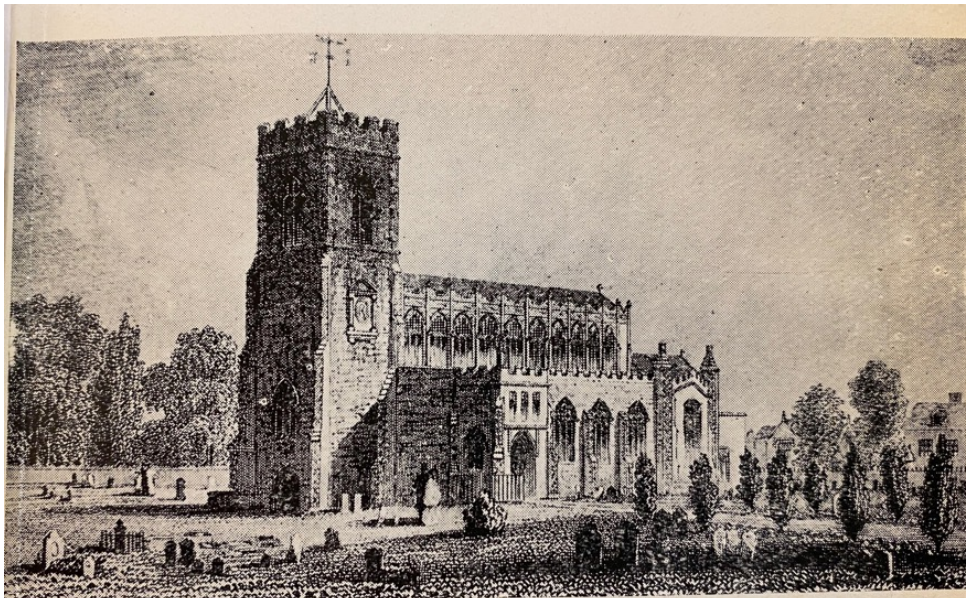
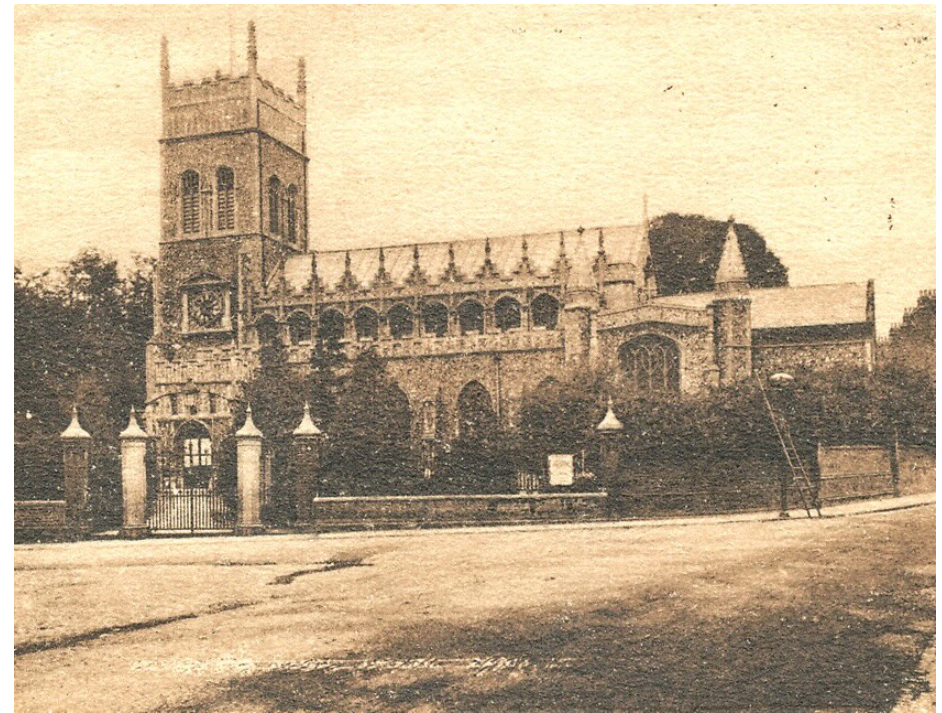
23. ST. MARGARET'S CHURCH.

Not much changed by 1830 but then the tower was raised in 1871. There are now two louvres for the bells, the height of the tower has been raised by the addition of flushwork and there are finials on the four corners of the tower. Also, there is a parapet where the south aisle wall joins the roof. You can just see the railings and gates and also a gas lamp and ladder in the second picture from about 1910.

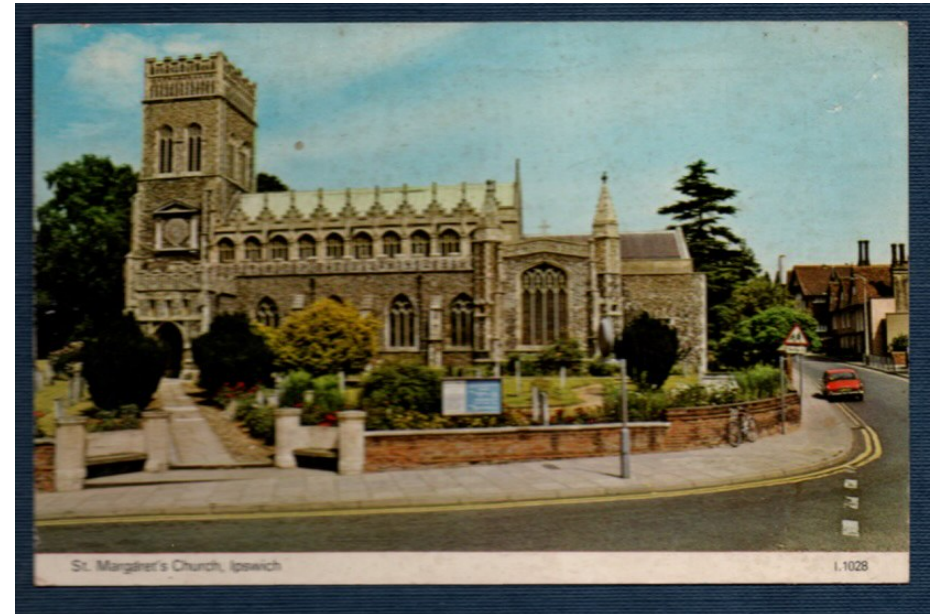
In 1957 Leonard Squirrel made a pen and ink drawing of the church. The gates and iron railings had been removed following bomb damage during the Second World War. The photo is from a 1970s postcard. Once again there are no finials on the corners of the tower! We think they had become so weathered that they had to be removed to ensure the safety of those walking below. They were replaced in the 1980s repair schedule. If you look outside today you will see that we have been replacing some stonework this year, once again for the safety of those below! The new stone looks much whiter but will weather.

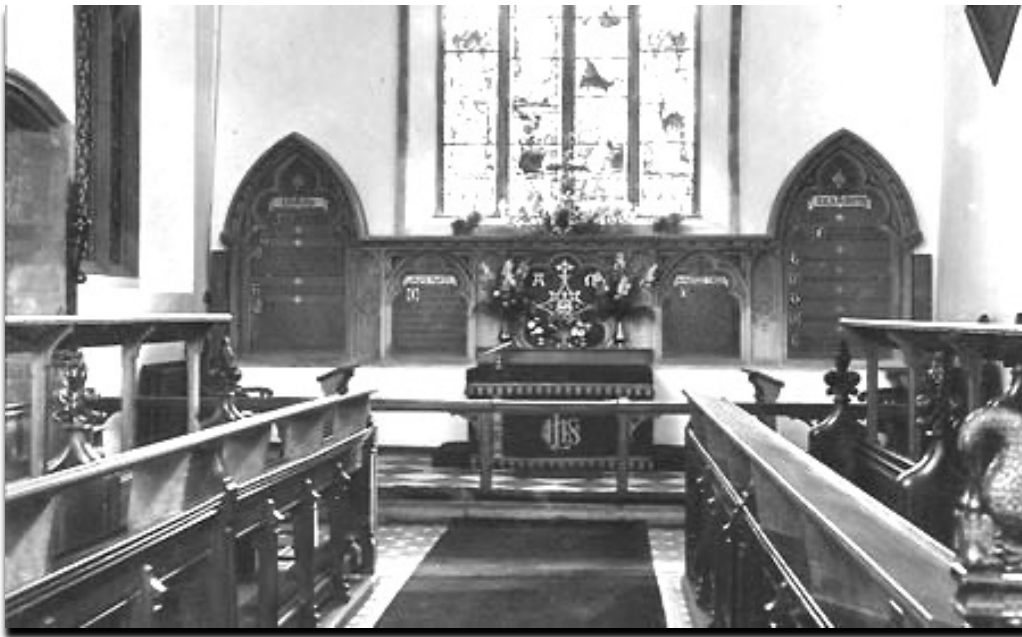
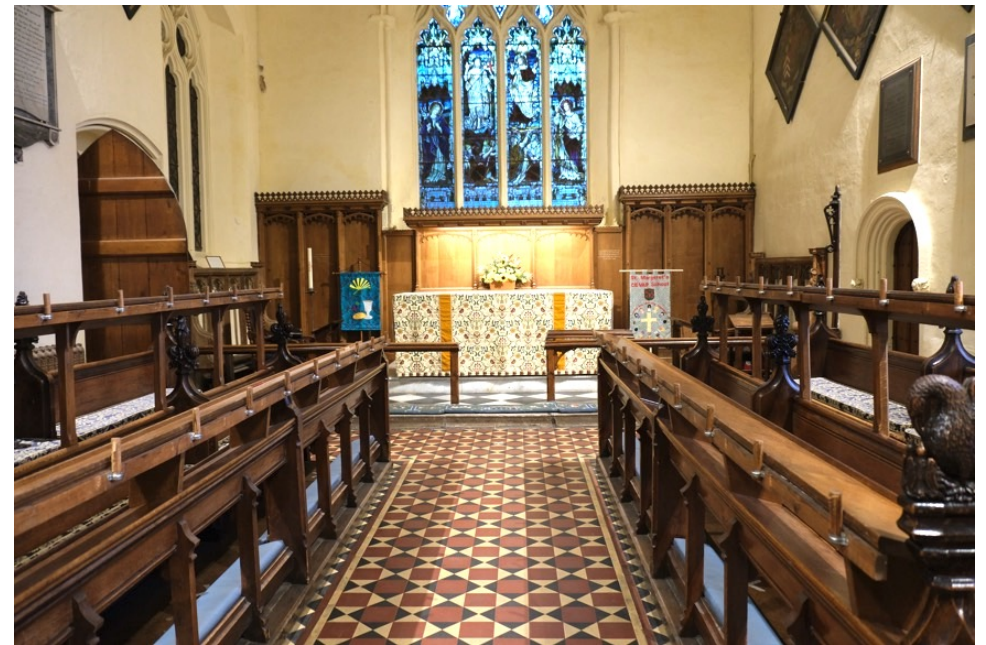
The left picture is thought to be 1930-50. The arched areas contained the Ten Commandments, the smaller left hand square (between the left arch and the altar) the Lord's Prayer and the right hand square (between the right arch and the altar) the Apostles' Creed. The new paneling was installed in the 1960s.

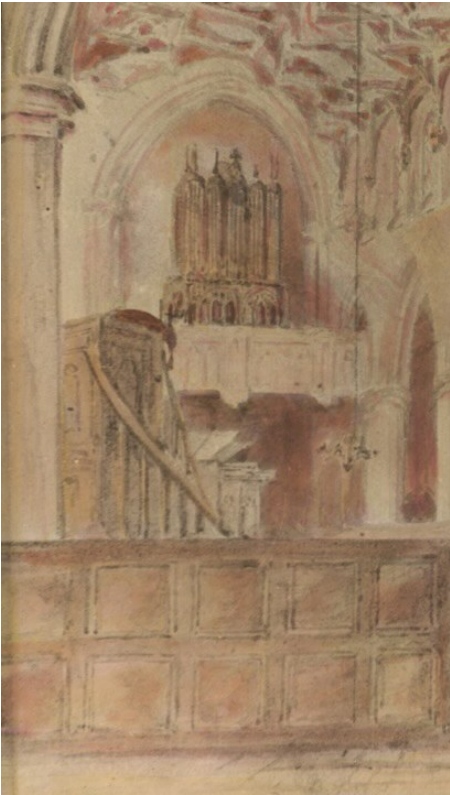
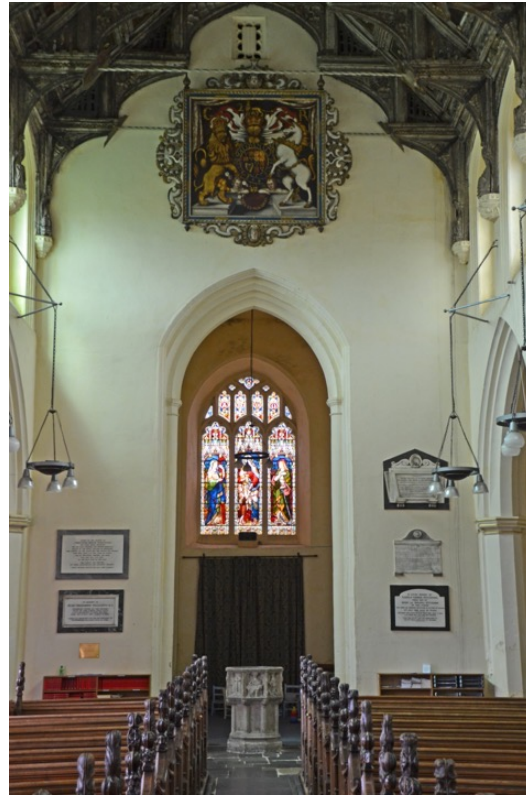
The first picture is taken from a painting by Frederick Davy dated circa 1840. It shows the organ in a gallery at the west end. This was removed in 1846 and for many years the middle picture was the view seen from the east end. More recently in 2018 a new ringing floor was inserted into the upper part of the tower arch.

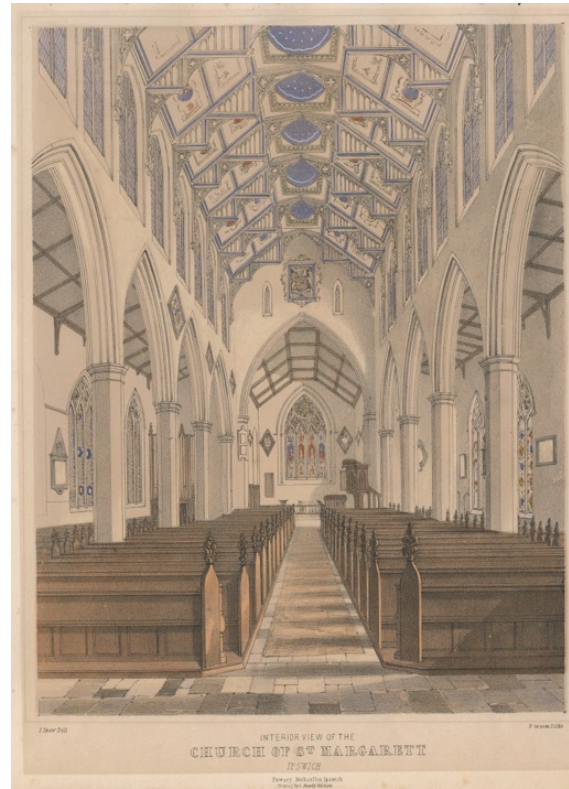
The first picture is the whole painting by Davy circa 1840. It shows the box pews in the nave. They were removed in 1846, and the current pews were installed. The second picture is of a lithograph from an engraving made in the mid 19th century looking towards the east end of the church and is much as it appears today. However, the Coat of Arms hangs above the chancel arch rather than at the west end. It also shows coloured glass in the north and south aisle windows.

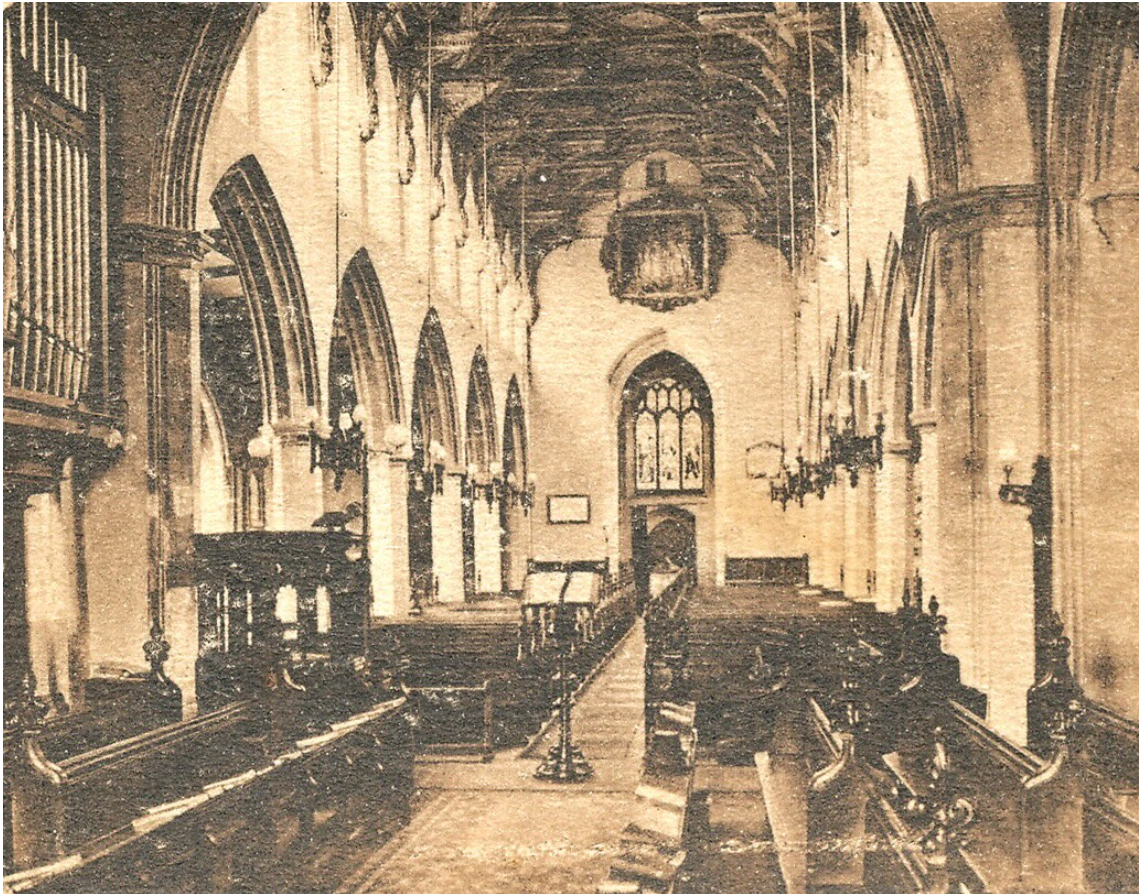
This picture is from about 1910. Note the position of the organ! In 1844 it was in the west end gallery. By the time of the lithograph a new organ had been installed in what is now the choir vestry in 1868. By the time this photo was taken the organ had been enlarged in 1906 and moved to the south transept. The present organ was installed in 1982 and placed in the north transept.

The lectern, prominently placed in the centre of the nave aisle, is still in use today and stands to the north side of the nave altar.
